RELIABILITY FIRST

2025 Misoperation Assessment

September 2025

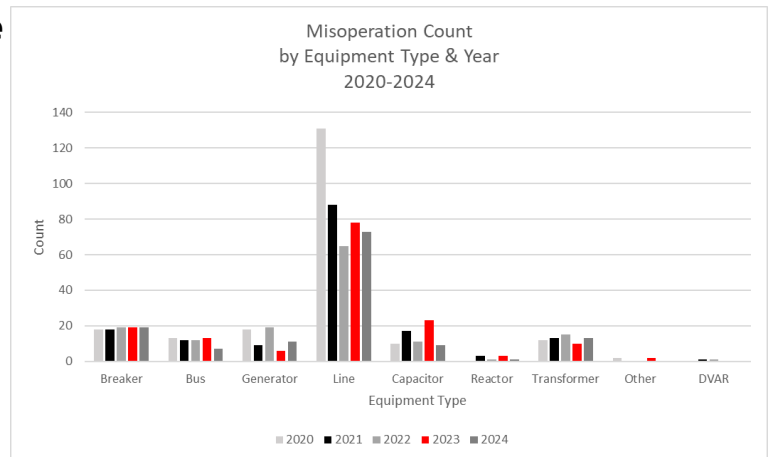
Figure 6 provides trend data from 2020 through 2024 of Misoperations by equipment type. Overall, these trends depict that equipment exposure (i.e., the larger the amount of equipment there is, the greater the potential is for a Misoperation to occur) correlates to the number of facilities placed in the field. Lines, transformers, and breakers accounted for 79% of the Misoperations in 2024.

Figure 6: 2020 to 2024 Misoperation Trending by Equipment Type
